## **EXPERIMENTAL STUDY ON RETROFIT TECHNOLOGIES FOR RC FRAMES WITH INFILLED BRICK MASONRY WALLS IN DEVELOPING COUNTRIES**

### **ABSTRACT**

*Keywords: developing countries; RC infill wall frame; retrofit solutions; timber framed masonry panel; ferrocement*

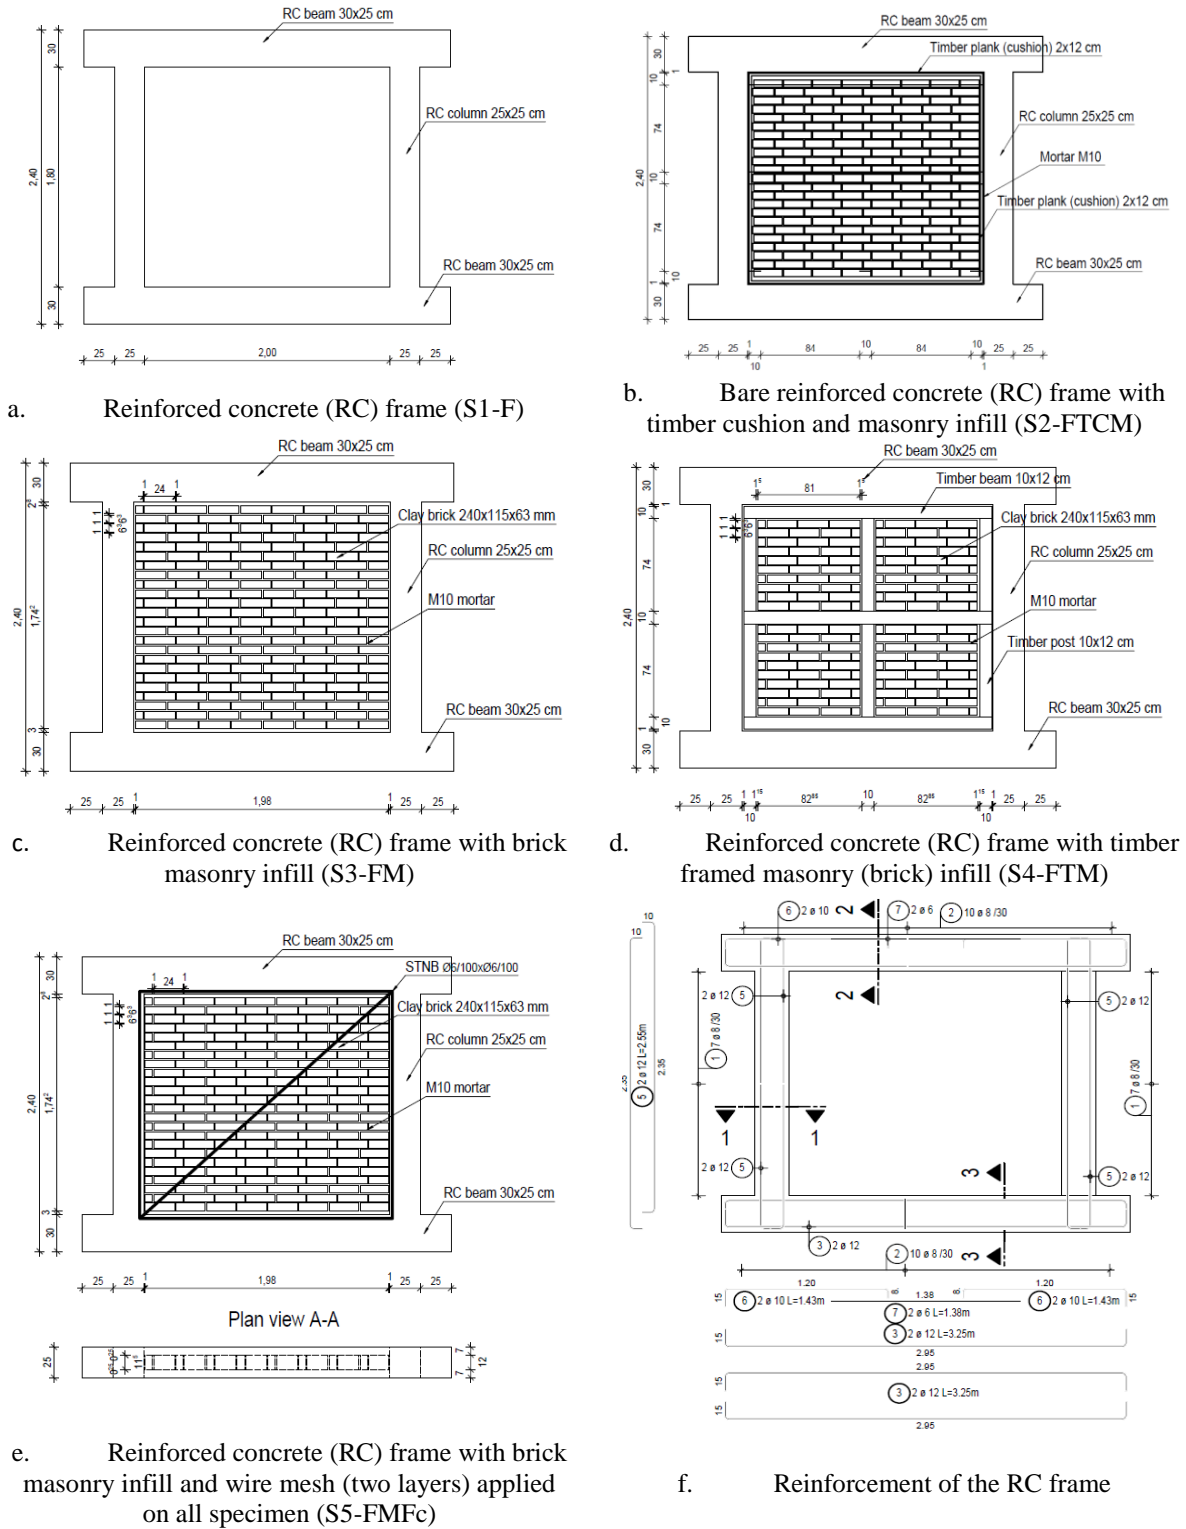
Figure 1. Test specimens' dimensions and layout and reinforcement of RC frame

The testing program included five specimens. Specimens details are presented in Figure 1.

The first specimen was a weak bare concrete frame. The rectangular columns (25x25cm) were reinforced with 4 $\phi$ 12 mm longitudinal rebars and  $\phi$ 8 mm stirrups spaced at 30 cm. The reinforcement details for all concrete frames are presented in Figure 1-f. The reinforcement ratio was 0.6% in case of the columns and 0.3% in case of the beams. These reinforcement details were chosen to reproduce the current practice for concrete frames in developing countries.

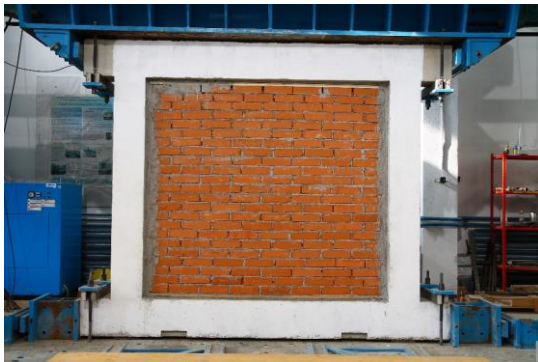
Figure 2. RC frame with timber cushion and masonry infill

The second specimen was retrofitting using a timber framed masonry panel. The masonry infill was made with burned clay bricks, available on the Romanian market with the dimensions of 240x115x63 mm. This infill detail was considered to partially transfer the masonry strut compression force to the surrounding concrete frame. The timber planks were considered to act as a cushion, based on the compression perpendicular to grain property of the timber. Between the timber plank and the concrete frame, a mortar layer of approximately 1 cm thickness was introduced. The same layer was introduced between the timber planks and the masonry, on all edges, except the upper part (Figure 2). The timber was Romanian softwood, fir.

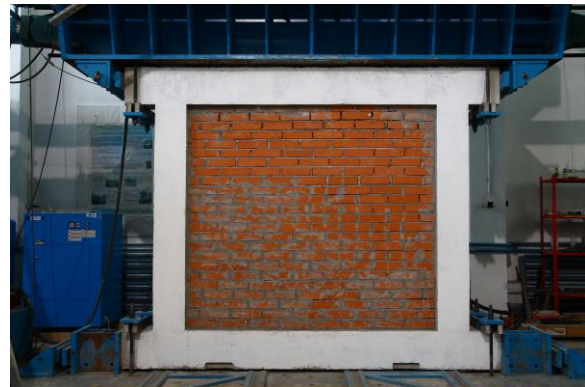
Figure 3. RC frame with masonry infill

In case of specimen S3-FM, a plain masonry infill panel was considered. The masonry infill was made with the same clay bricks as in the case of S2-FTCM. The layout of the specimen is shown in Figure 3. There were concerns that, given the weak concrete frame, the diagonal compression force in the masonry panel can severely damage the concrete frame at small lateral displacement. Similar masonry panels retrofitted using various techniques were previously tested by the authors (Seki, 2016, Popa 2010).

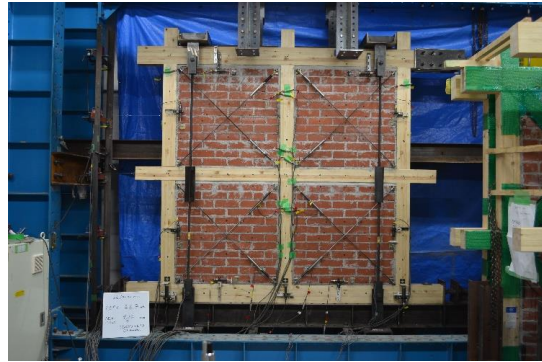
Figure 5. Previous experimental test in Tokyo Institute of Technology (Dutu et. al, 2015)

In case of specimen S4-FTM, a timber framed masonry panel was used. The infill panel was made using a timber frame, with cross-halved timber connections (Figure 4), and masonry, with cement based mortar. Common construction materials, readily available, were used. The dimensions of the timber framed masonry panels were chosen based on previous experimental study (Dutu et. al, 2015) in Tokyo Institute of Technology (Figure 5).

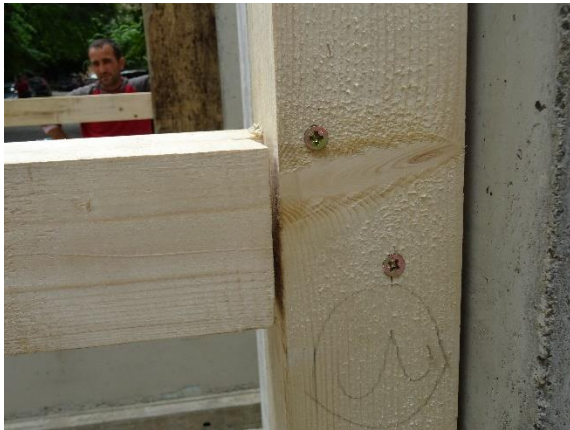
Figure 6. Connection execution error – existing big gap

Some of the connections had undesirable construction gaps, as shown in Figure 6. This reflects the reality of the current construction practice in developing countries. The connection between the timber frame and concrete frame was made using lime-cement mortar, manually introduced in the gap (Figure 7). Properties of the mortar are given in the subsequent paragraph. The timber was Romanian softwood, fir.

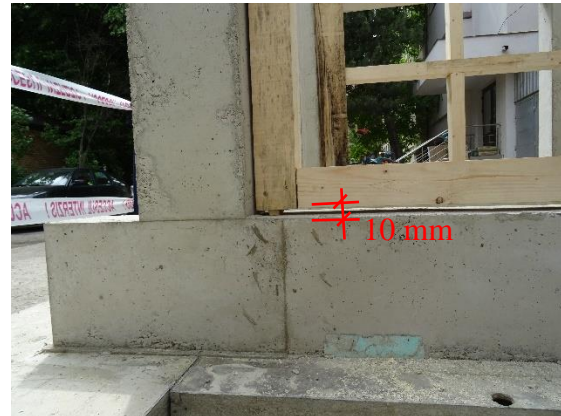
Figure 7. Gap between the RC frame and timber frame, filled with finishing mortar

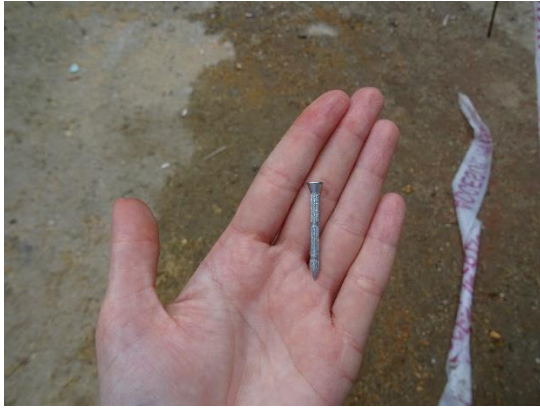
a – nails used to position the wire mesh on the concrete (mesh was at 1 cm distance from the concrete surface)

Specimen S5-FMFC was a concrete frame retrofitted using a masonry panel jacketed with steel wire mesh reinforced mortar. Wire mesh with  $\phi 0.9\text{mm}$  wires spaced at 13 mm on both directions was used. The wire mesh was fixed on the concrete elements with nails (Figure 8-a and b) and on the masonry wall with small clamps (Figure 8-c and d). Wire meshes were 25 cm overlapped (Figure 8-f). Initially, two 1,0 m wide meshes were applied on the masonry panel overlapped on the horizontal direction (Figure 8-g). Then a wire mesh was installed on each RC beam overlapped with the masonry meshes on 25 cm (Figure 8-g). In the third step, two 1m wide meshes were applied on the columns, overlapped on the horizontal direction (same as on the masonry panel) and overlapped on the masonry panel on 25 cm. The mesh was bent over the column and between the column and the masonry with a wooden batten (Figure 8-h). The fourth step was to apply a second layer of mesh on the masonry panel, but this time, the overlapping (also on 25 cm) was made on vertical direction, and three pieces of wire mesh were used (two being 1 m wide each and another being 0.5 m wide) (Figure 8-i). Between the mesh and the infill or RC elements, a gap of maximum 1 cm was left, so the wire mesh could be well embedded in the finishing mortar.

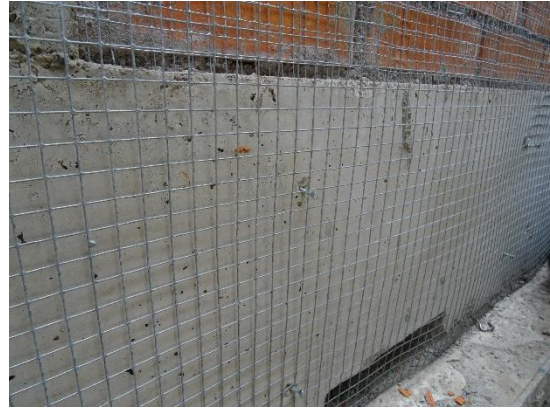
b – mesh applied on the concrete surface and also on the masonry

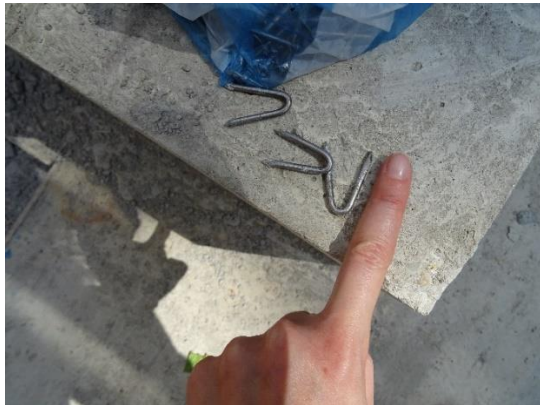
c – the clamps used to position the wire mesh on the masonry panel, embedded in the mortar joints

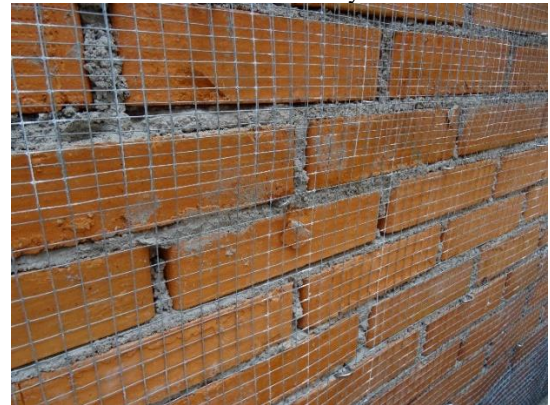
d – the clamps applied to position the wire mesh on the masonry panel, embedded in the mortar joints

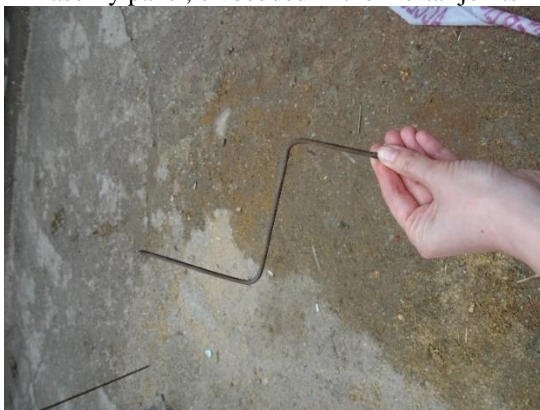
e – the tie wire used to connect the wire meshes on both sides of the masonry panel

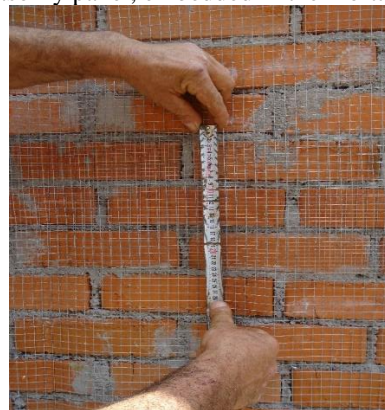
f – overlapping of the wire mesh

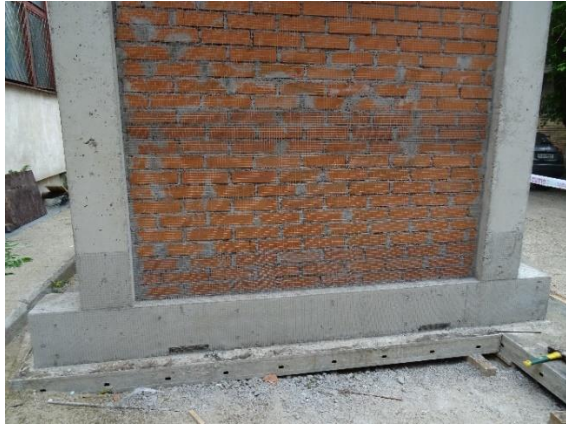
g – overlapping wire mesh from RC beam on the masonry

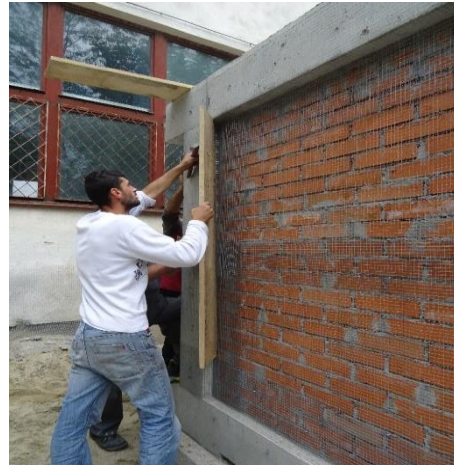
h – bending the wire mesh to follow the shape of the column with a wooden batten

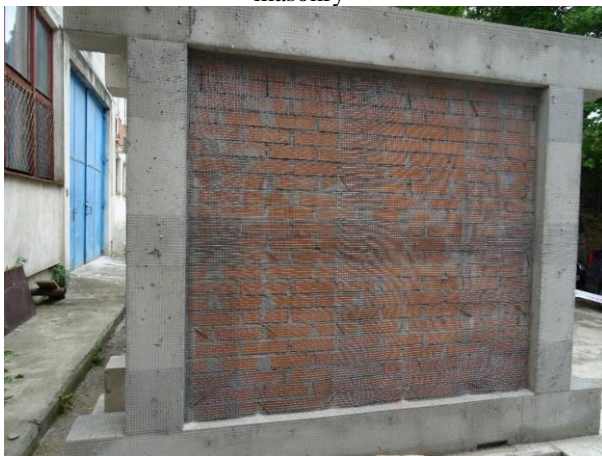
i – all wire meshes are applied

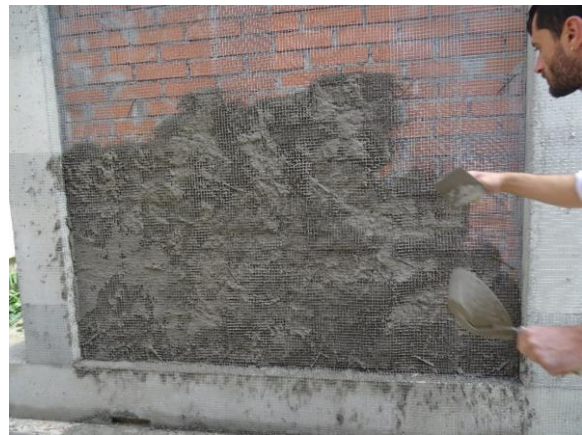
j – the mortar finishing is applied by hand throwing

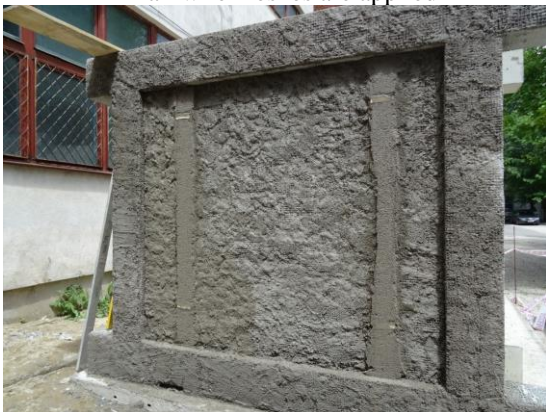
k –starter layers applied for reference thickness of the mortar layer

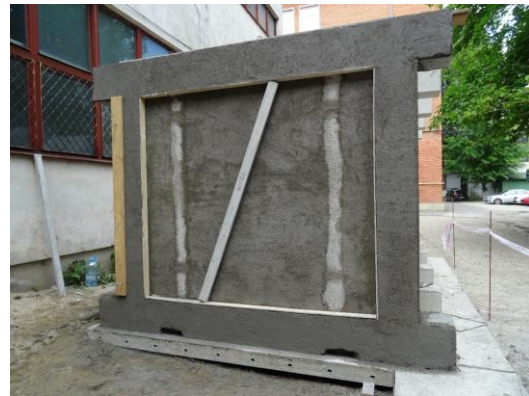
l – finished specimen

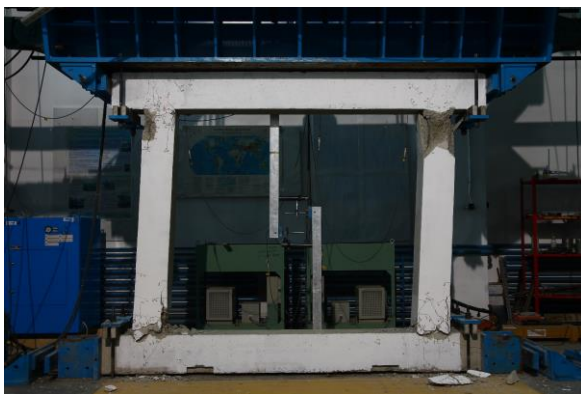
Figure 11. Frame's (S1-F) failure at 2 % drift (left) and hysteric curve

The maximum recorded lateral force was 81 kN, corresponding to 1 % lateral drift. The failure occurred at 2 % drift, in the negative cycle (Figure 11). The damages concentrated in the columns. Although some cracks occurred in beams, no significant damages were noticed in these elements (Figure 11).

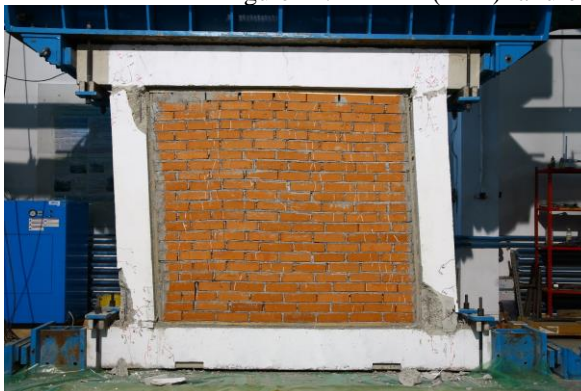
Figure 12. Frame's (S2-FTCM) failure at 4% drift (positive cycle) (left) and hysteric curve (right)

The maximum recorded lateral force was 122 kN, corresponding to 4.2 % drift, on the positive cycle, and 168 kN corresponding to 3% drift on the negative cycle. The lateral strength was maintained up to 4% drift in the positive cycle (Figure 12). The damage was concentrated in the columns, top and bottom. A diagonal tension crack followed by shear sliding were noticed in the masonry. The cracks went through both mortar joints and bricks. The masonry panel together with the timber frame detached from the RC frame from early cycles. The hysteretic curve shows the significant contribution of the timber framed masonry in increasing the lateral strength and ductility of the concrete frame. A hardening phenomenon caused by the compression perpendicular to grain property of the timber was observed.

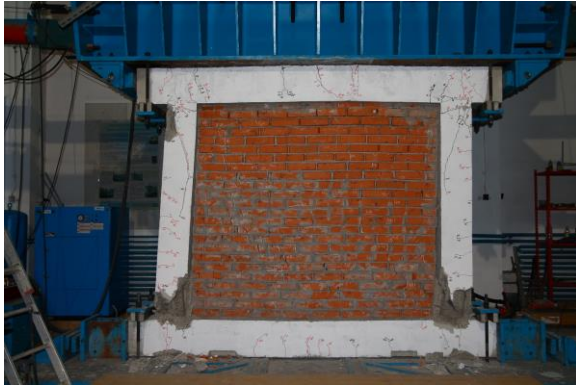
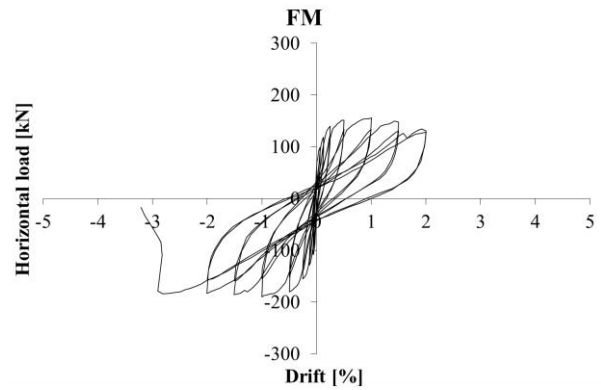
Figure 13. Frame's (S3-FM) failure at 3% drift (left) and hysteric curve (right)

S3-FM specimen failed at 3% drift, with the loss of the axial force carrying capacity caused by the shear failure at the bottom of the columns. Transfer of the axial force to the masonry infill was observed (Figure 13). The recorded maximum lateral force was 190 kN, at -1 % drift. The masonry showed two types of failure mechanisms: diagonal tension crack and shear sliding. Initially one diagonal strut developed in the masonry. Subsequently, progressive damage of the masonry panel favored the development of several struts with a relative uniform compression field. The RC frame's collapse occurs due to the shear failure of the columns at the bottom.

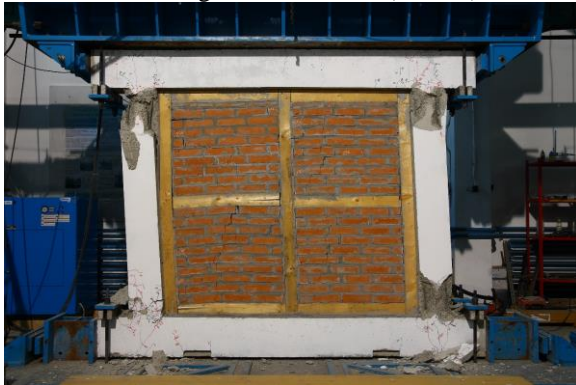
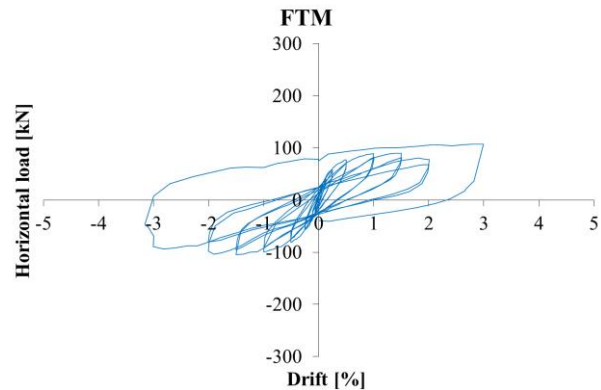
Figure 14. Frame (S4-FTM) at 3% drift (left) and hysteric curve (right)

The specimen maintained the lateral strength up to 3% drift after the shear failure of the columns at the bottom and at the top. The maximum lateral force was 107 kN, at 3 % drift (Figure 14). In the beginning of the test, the masonry panel rotated, due to the gaps in the timber frame's connections. After the rotation in the timber joints reached the necessary level to close the gaps, or to exhibit compression perpendicular to grain in the timber elements, the masonry panels started to fail in shear sliding mode. As it can be seen in the hysteric curve, after entering the plastic range, the specimen had a stable envelope until the RC frame failed. This is due to the shear sliding in the joints of the masonry panels and the timber which gives flexibility in the same time with confinement for the panels. Initially, strut and tie is obvious in the panels, but gradually, with the shear sliding, several struts appear (i.e.: one in the upper part and one in the lower part) or the direction of the strut changes. In the end of the test, after the columns lost the axial load, it was naturally transferred to the neighboring timber framed masonry panel, and this was observed by the compression perpendicular to grain in the lower timber beam. Even from the beginning, the lower masonry panels (left and right) showed an out-of-plane sliding of 2, and respectively 4 mm. Until the end of the test, the out-of-plane movement reached 4 and 10 mm, respectively. In the beginning, the shear sliding occurs in the infill, in the lower panels, and gradually, the cracks appear in a stepwise way, especially in the upper panels.

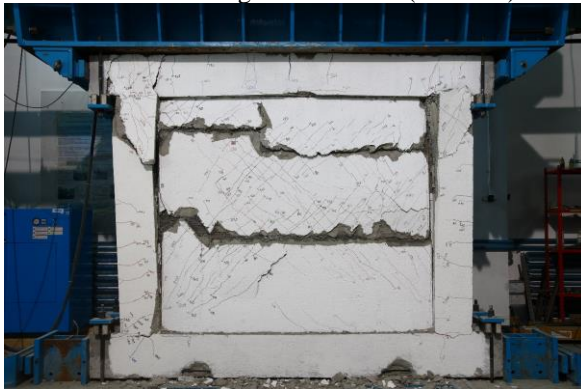
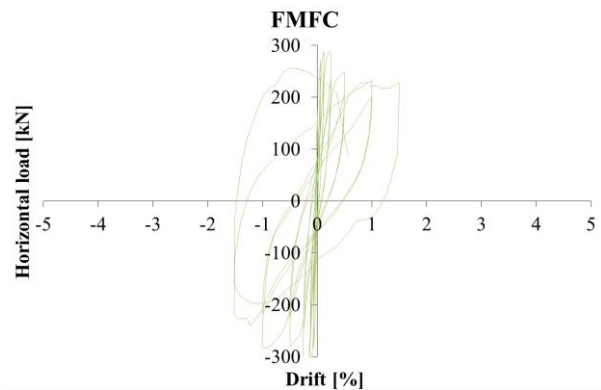
Figure 15. Frame's (S5-FMFC) failure at 1.5 % drift (left) and hysteric curve (right)

Specimen S5-FMFC failed at 1.5% drift (Figure 15), due to shear failure at the upper part of the columns. The maximum recorded lateral force was 321 kN, at -0.25 % drift. Two types of masonry failure modes were observed: diagonal compression and shear sliding. The shear sliding was significantly observed on two horizontal joints, which created three panels, therefore three struts which pushed into the columns and distributed the damages along its height, rather than concentrate them in the bottom. The wire mesh was tensioned, thus pulled and twisted (in some areas) outside the plane, causing the damage of the mortar.

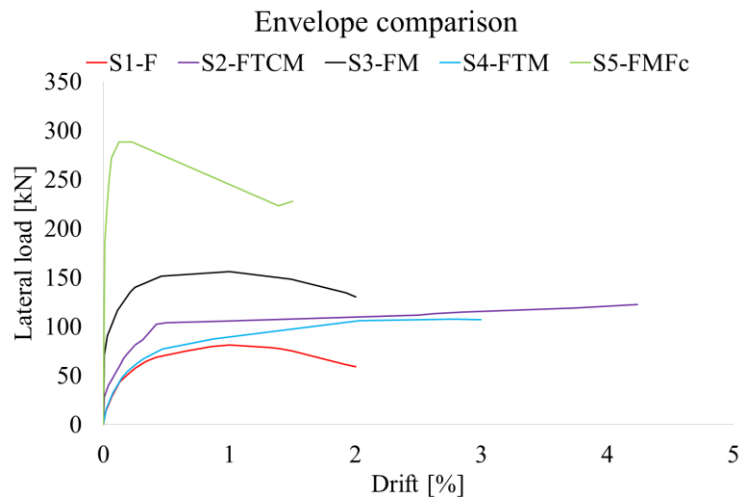
Figure 16. Comparison of all specimens' envelope curves

The masonry infilled frame, S3-FM, has almost double lateral strength in comparison with S1-F with similar lateral displacement capacity. Figure 16 shows that the envelope curves are highly similar, but with a constant strength difference of almost 100 kN.

The S4-FTM retrofitting technique significantly the ductility up to 3 % drift. A slight increase of the lateral strength in comparison with the reference specimen was recorded as well. The timber frame produced the hardening behavior which can be observed in Figure 16.
