# INFLUENCE OF AXIAL FORCE APPLICATION IN THE BEHAVIOR OF TIMBER FRAMED MASONRY WALLS UNDER IN-PLANE STATIC CYCLIC LOADING

Andreea Dutu<sup>1</sup>, Hiroyasu Sakata<sup>2</sup>, Yoshihiro Yamazaki<sup>3</sup>, Mihai Niste<sup>4</sup>, Iulian Spatarelu<sup>5</sup>

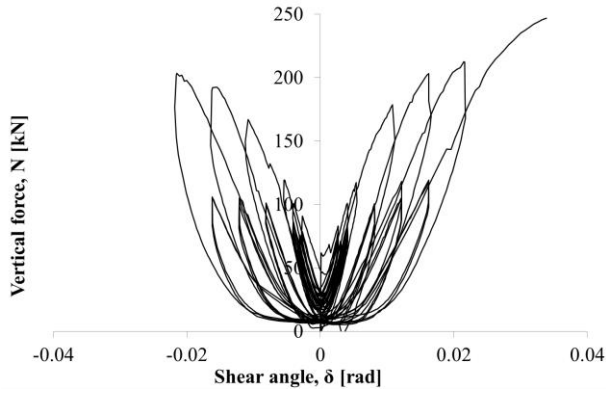
The vertical force introduced initially was 60 kN, but it increased directly proportional with the uplift and the displacement at the top (Figure 6). Although it is not clear the how much percentage of the axial force is distributed to the masonry panels and how much to the timber frame. It is known that the axial load has a significant influence in the shear capacity of the masonry, especially in TFM systems, where friction plays an important role due to the characteristic failure mode in shear sliding.

Figure 6: Variation of the vertical force with shear angle

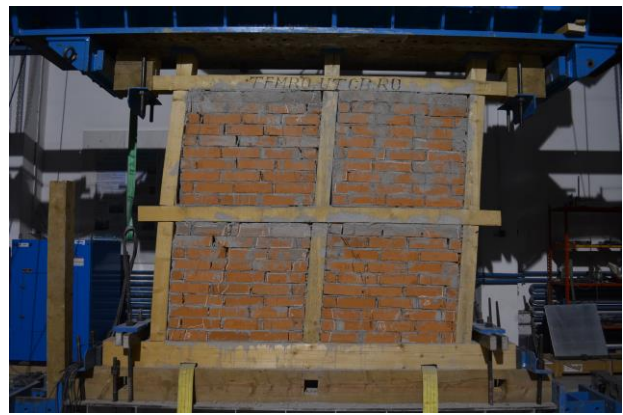
**Figure 10:** Specimen's last cycle at 6 % drift

The specimen showed a maximum strength of 49.5 kN (Figure 9), corresponding to 5.3 % drift, and a was tested until 6% drift when the jack's stroke limit was reached (Figure 10).

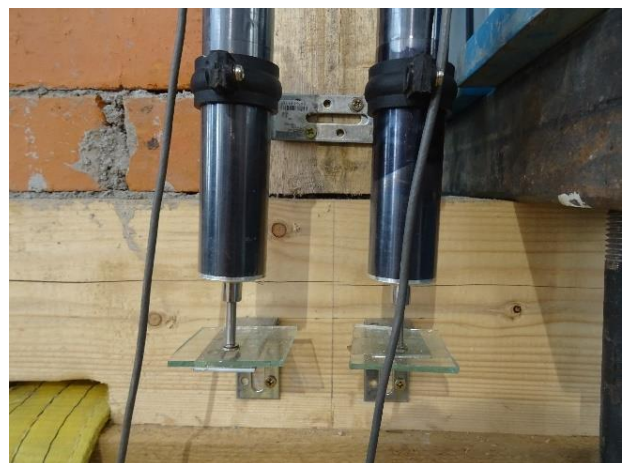
The specimen had a poor execution, specific for developing countries and gaps were obvious in the connections even before the test started (Figure 11). Moreover, due to the shrinkage process which was not done industrialized in the oven, some of the timber elements were distorted from initial state (Figure 12).

**Figure 11:** Gap in the connection due to poor execution

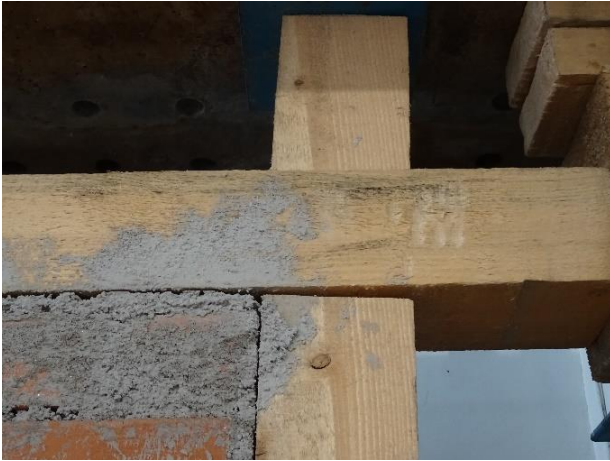
**Figure 12:** Execution errors: gap in the connections and distortion of the column

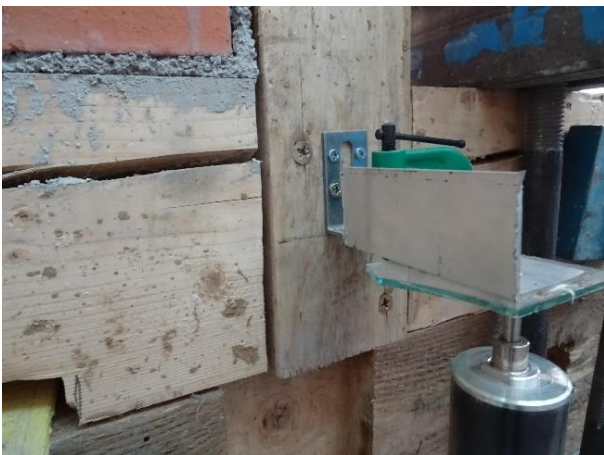
Another type of execution error was considered the superficial cracks, present in many of the timber elements. Although superficial, they still represent defects of the timber, thus are considered weak parts.

**Figure 13:** Gap in the connection due to poor execution and superficial crack in the bottom beam

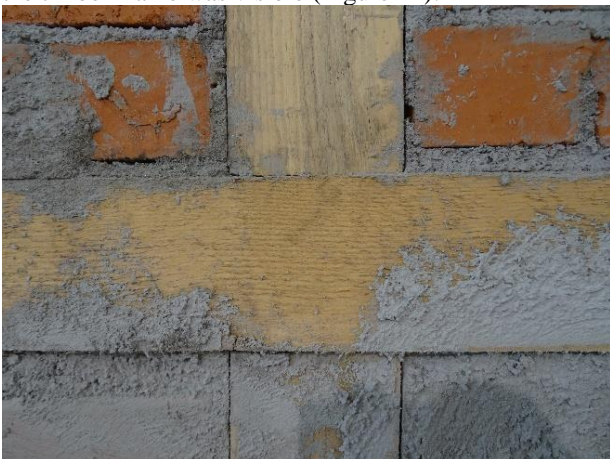
From early cycles in the beginning of the loading protocol, the separation between the masonry infill and the timber frame was visible (Figure 12).

**Figure 14:** Separation of the masonry infill from the timber frame

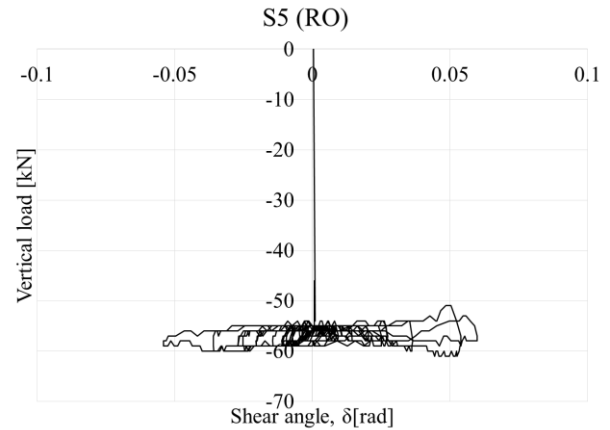
The axial load versus the shear angle is shown in Figure 15. A light variation is observed for large displacements, but still in a neglecting values range.

**Figure 15:** Axial force value for Romanian specimen

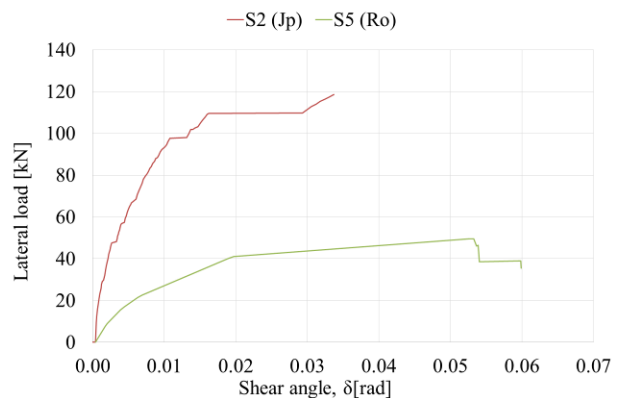
The envelope curves are compared in Figure 16. The stiffness difference is observed. The strength of the Japanese wall was 2.6 times higher than the one of the Romanian test.

**Figure 16:** Comparison of envelope curves for Romanian specimen and Japanese specimen

The tests were not perfectly identical in terms of setup, so differences may occur initially from the test method. However, the difference being so large, other factors had to influence this result.

The most important factor was the axial load, which is known to contribute to the shear capacity of the masonry infill. Then, there was the poor execution quality in the Romanian specimen, compared to the Japanese specimen. For the first one, the connections were cross-halved on site, by chisel and hammer, while for the latter the cutting of the timber was done in the factory with very precise machines.

Another reason can be the difference in strength of the materials, which is 3 times lower for masonry prism in compression, for the Romanian test. The mortar was also half value, considering the average.

The timber bending strength was two times lower for the Romanian timber, while the brick compressive strength was 25 % lower.
